Road Safety Audit Report

Claremont, New Hampshire

New Hampshire Route 11 (Washington Street)

Claremont Compact – Dane Avenue to Winter Street

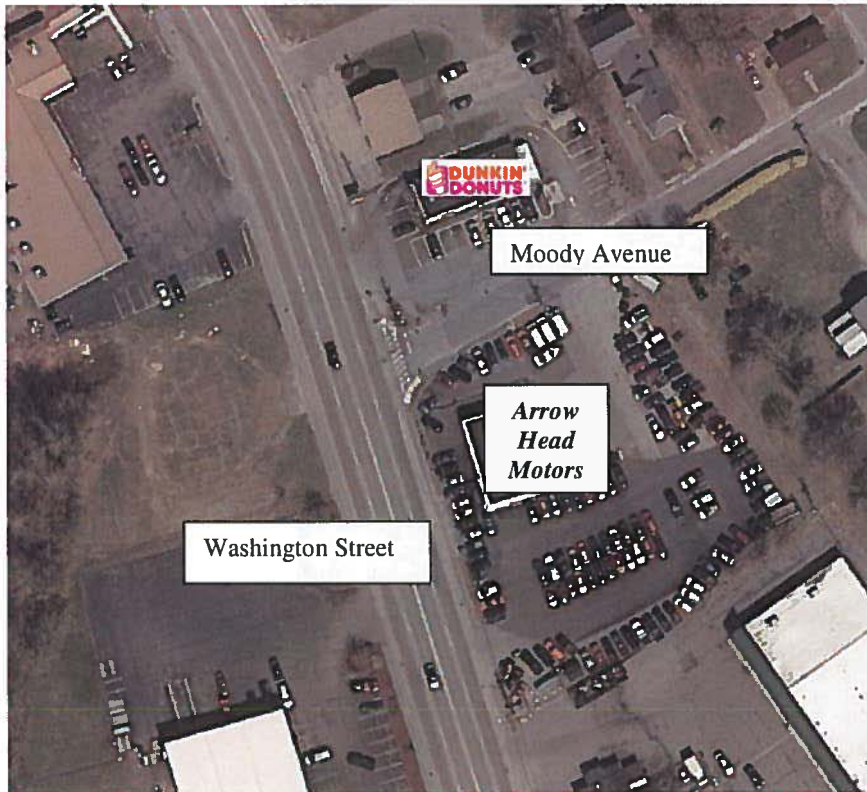
Location: Intersection of Moody Avenue and Washington Street

Description of Safety Issues: Moody Avenue provides primary access to Washington Street for approximately forty residences, and secondary access for two businesses. The business (Arrow Head Motors) on the southeast corner of Moody and Washington Street has recently closed down an access point on Washington Street that was in close proximity to Moody Avenue. However, the manner in which they display their vehicles restricts the sight distance for vehicles entering Washington Street from Moody Avenue. City planning staff indicated that a new business may be opening in the vacant space on the west side of the intersection.

Suggestions: The obvious suggestion at this location is to work with the business on the southeast corner to open up the sightline for vehicles turning left or right onto Washington Street from Moody Ave. Other recommendations include restricting Moody Avenue to “right out” only movements. Further enhancements depend on the proposed development on the west side. Channeling traffic from existing and future business to one access point and installing a signal is a potential option.
